# **Evaluation of Seismic Behavior of Damaged Offshore Jacket Platform under the Environmental Conditions**

Amirreza Zafarjoo<sup>1</sup>, Rouhollah Amirabadi<sup>2\*</sup>

<sup>1</sup> Marine Structure at Petro Darya Energy Co., Tehran, Iran; a.zafarjo@petrodaryaenergy.com <sup>2</sup> Assistance professors, University of Qom, Qom, Iran; r.amirabadi@qom.ac.ir

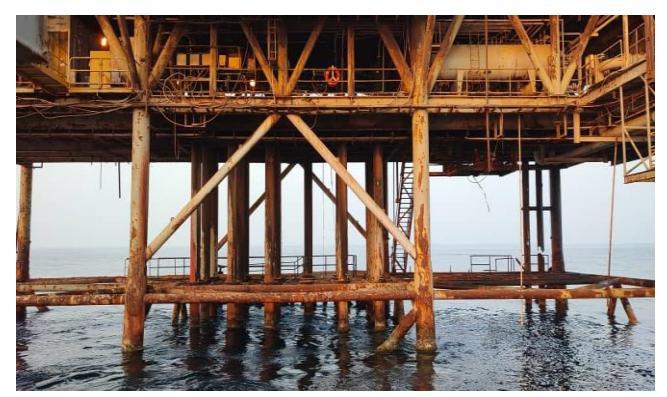
Figure 2. General Condition of Members in Splash zone

Regarding actual subsea inspection reports, several structural members are suffering from excessive corrosion, flooding, marine growth effects, and anode wastage. No fractures or dents were observed in the members and welds [17]. Figure 2 shows the general condition of the jacket members in the splash zone.

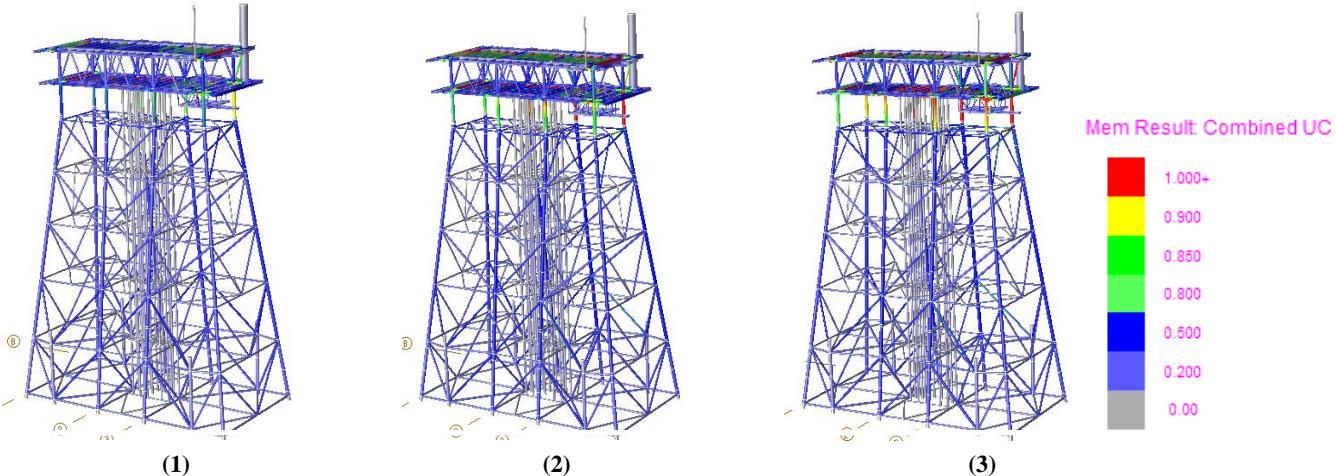
Figure (12). UC range of Members in first (1), second (2) and Third (3) Scenarios

Regarding the results of linear seismic analysis, the legs in the splash zone between the working point to the deck legs are in the critical range of unity check. UC of mentioned legs is decreased along the members from up to downward. Most of the braces are in the UC range between 0.1 and 0.3. Also, horizontal members with UC 0.1 to 0.5 are in acceptable condition. Implemented damages like; flooding the members and corrosion have no significant effect on UC. The UC ranges in the second scenario are similar to the first one. Increasing the topside weight in the second scenario has led to an actual stress increase in deck legs. However, these mentioned increased stresses did not affect on strength of bracing members.

The UC values are higher than the two previous cases in the third scenario. Also, the number of members has nonlinear behavior. Regarding the results of the third scenario, the initial design criteria and the assumed corrosion rate are conservative and the structure has less corrosion rate in its present condition. Also, considered damages in the initial design have never occurred for the platform until 2020. The nonlinearity of the braces in all three cases indicates their design criteria following a more robust force such as wave force. By controlling the members above the soil surface, it was determined that the most critical members under the earthquake force in all three cases are the jacket legs connected to the deck. There are 0, 5 and, 7 members with critical UC in the first, second and, the third scenarios, respectively.

Figure (12) illustrates the UC range of jacket members which are located above the seabed.

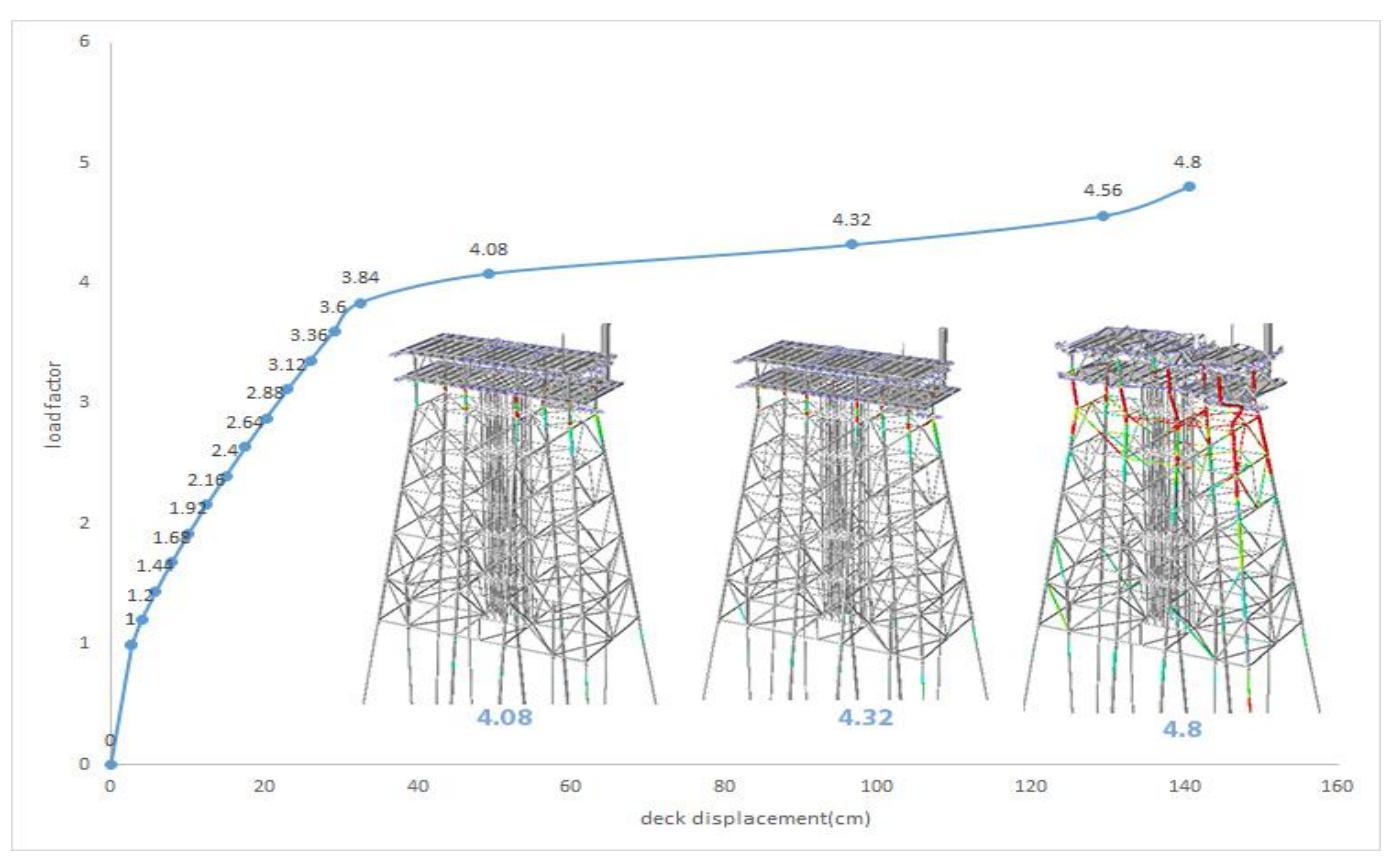
Figure 15. Capacity and Plasticization Rate of the Structure in the First Case

Regarding capacity diagram of the structure in the first scenario under abnormal level earthquake forces in direction No.1, Diagonal members are buckled and plastic hinges have occurred to develop in the deck legs. The first plasticization with a 16% rate occurred in the legs which connected to the deck at a load factor of 1.88. This mentioned plasticization has no significant effect on the behavior of the damaged structure.

While the loading process continues at a load factor of 2.84, the structure begins to yield and reduce stiffness.

Plasticization of skirt piles and some horizontal members begin at the highest level of the jacket at a load factor of 3.08. Plasticization of the other horizontal members of the seadeck is stared at load factor 3.32. The first yield has occurred on the deck legs in the splash zone due to corrosion and lack of diagonal braces in this elevation. A plastic joint on the deck legs with in load factor of 3.56 has led to a change in the transmission of force from the legs to the horizontal members and VDM braces. Finally, 100% plasticization of deck legs and piles in the soil leads to the collapse of the structure at a load factor of 3.8. Figure (15) shows the displacement - load coefficient of the structure under gravity and lateral loads. The load factor from 0 to 1 is related to gravity loads. During the pushover analysis in the first scenario, no punching occurred in the piles and the soil has sufficient strength under the abnormal earthquakes up to a load factor of 3.8.

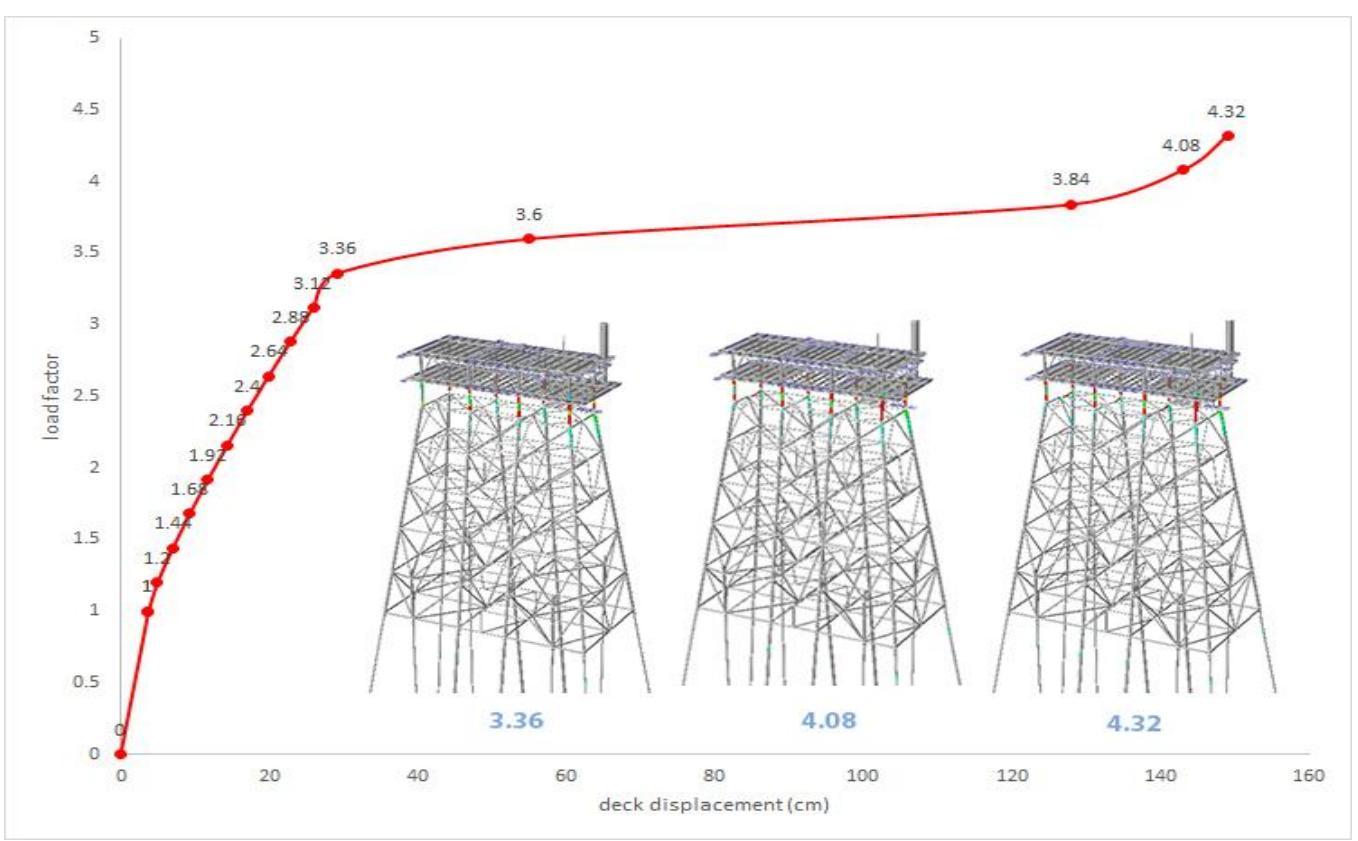
Figure 16. Capacity and Plasticization Rate of the Structure in the Second Case

The second scenario represents the actual condition of the structure. In the current scenario, due to the increase of the deck's weight, the members' plasticization occurred at a lower load factor with a higher percentage of yield. However, this increased weight has no significant effect on the fracture mechanism of the structure. The leg of the jacket and the diagonal braces have considerable roles against seismic load, respectively. No punching has occurred on the piles below the mudline. Also, plasticization of the piles has decreased along the piles from up to downward. The first yield has occurred in the deck leg, which is located below the crane. Although, plasticity is developed, platform failure is not happening and conforms to the ALE requirement. The structural leg elements are allowed to behave plastically developing the reserve strength of the cross-section, and making use of ductility and energy dissipation to resist ALE factors. Figure (16) illustrates the capacity diagram of the structure.

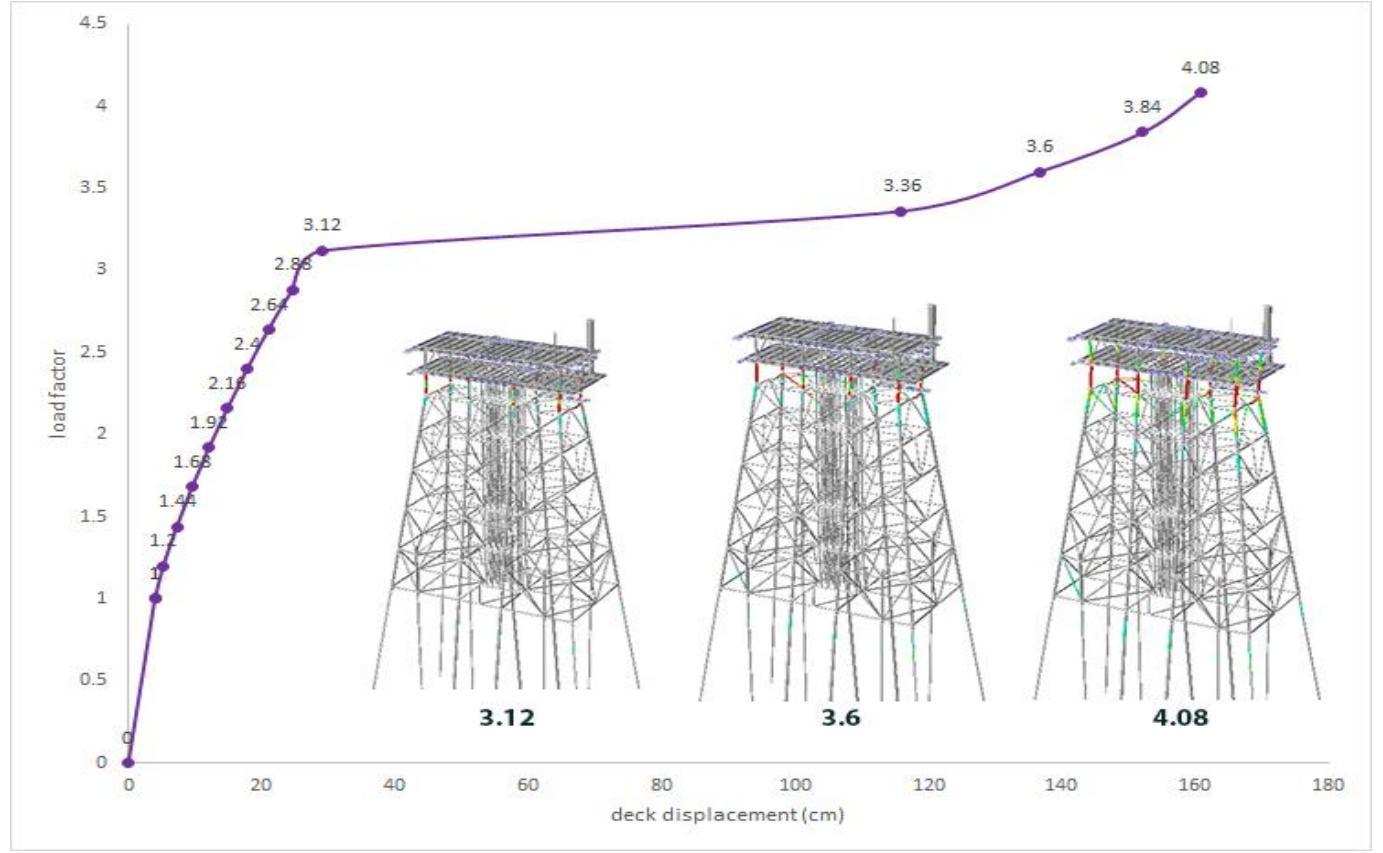
Figure 17. Capacity and Plasticization Rate of the Structure in the Third Case

The behavior of the structure in the third case is similar to the two other scenarios. However, the strict criteria and the considered damages in the initial design criteria of the structure have not happened properly. Although, damages in the initial design basis are more conservative than in other cases, and the actual condition of the platform and led to the collapse of the structure at a lower load factor than the other two cases. The 8% difference in the Strength ratio between the second and third scenarios indicates the effect of damages like corrosion on the RSR of the structure. The bending has occurred on the deck legs below the heavy crane. Also, diagonal braces which are located near the crane are near to buckle. The result of the global inelastic seismic analysis of the structure indicates that the structure has suffered damages consisting of the buckling of some diagonal braces in the splash zone and the yielding of deck legs during the abnormal earthquake. So, the platform has a minimum RSR of 3.32 under a 1,000-year return period earthquake event. It is concluded that despite the poor performance and condition of some members and joints, especially in the splash zone and deck legs, the platform can fulfill API for the structural assessment against seismic loads.

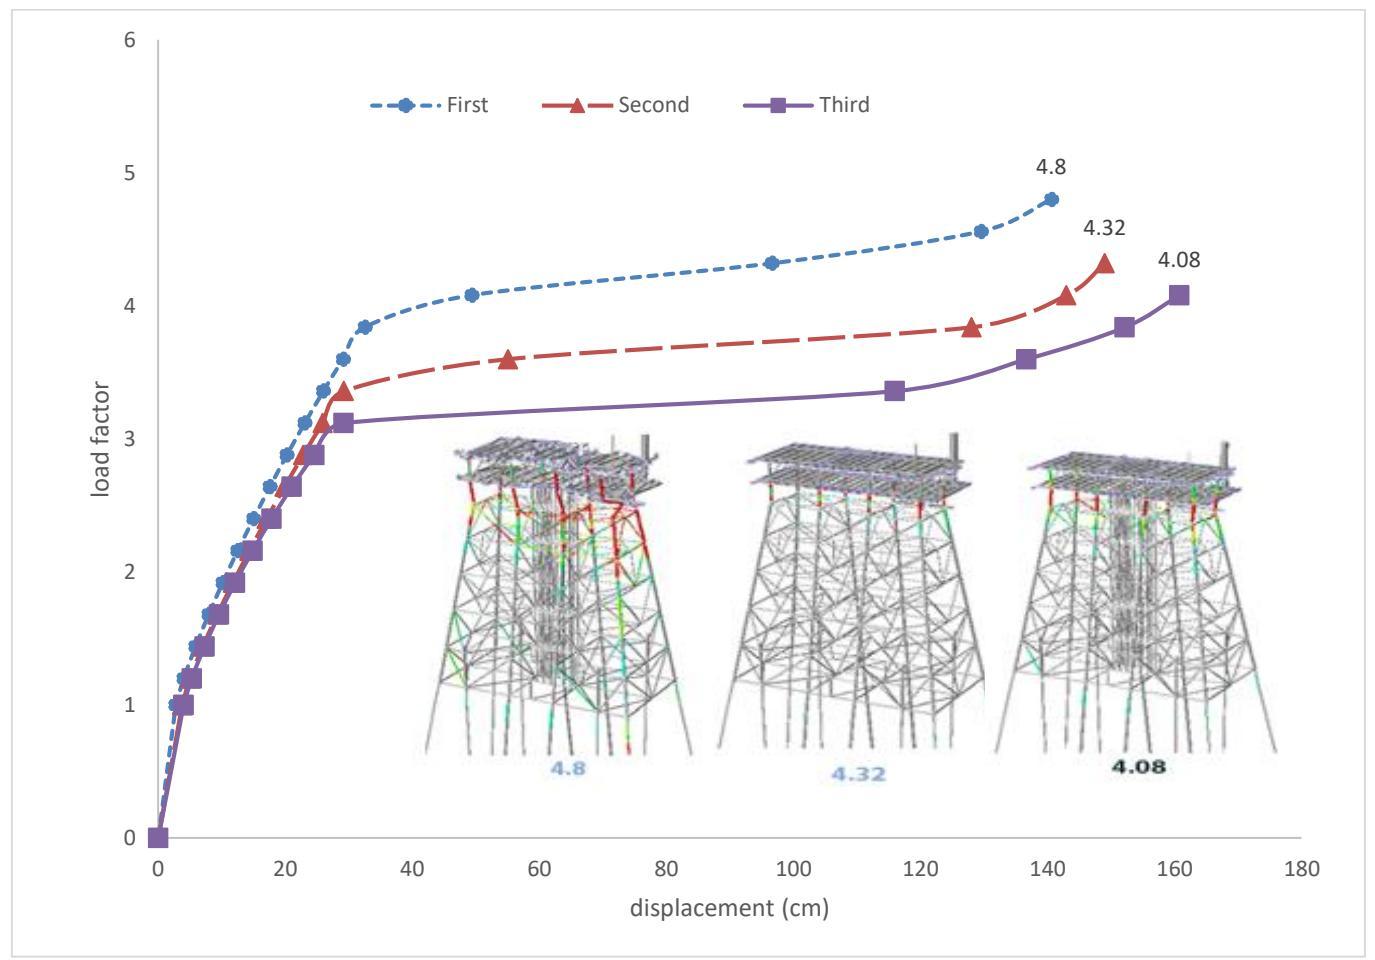
Figure 18. Comparison of Capacity Diagrams in Three Scenarios

6. According to Figure 18, the implemented damages have no considerable effect on the structure's integrity. Also, reducing or increasing the weight of the topside has led to changes in the RSR and the percentage of plasticization of critical members.

Deck legs have suffered from bending and diagonal braces suffered from buckling under the seismic loads.
 Buckling in the deck legs at the splash zone and yielding in the Piles near the seabed causes global structural collapse under the ALE pushover analysis.
