INTERNATIONAL JOURNAL OF MARITIME TECHNOLOGY

IJMT Vol.18/Spring & Summer 2023 (25-39)

Evaluation of Seismic Behavior of Damaged Offshore Jacket Platform under the Environmental Conditions

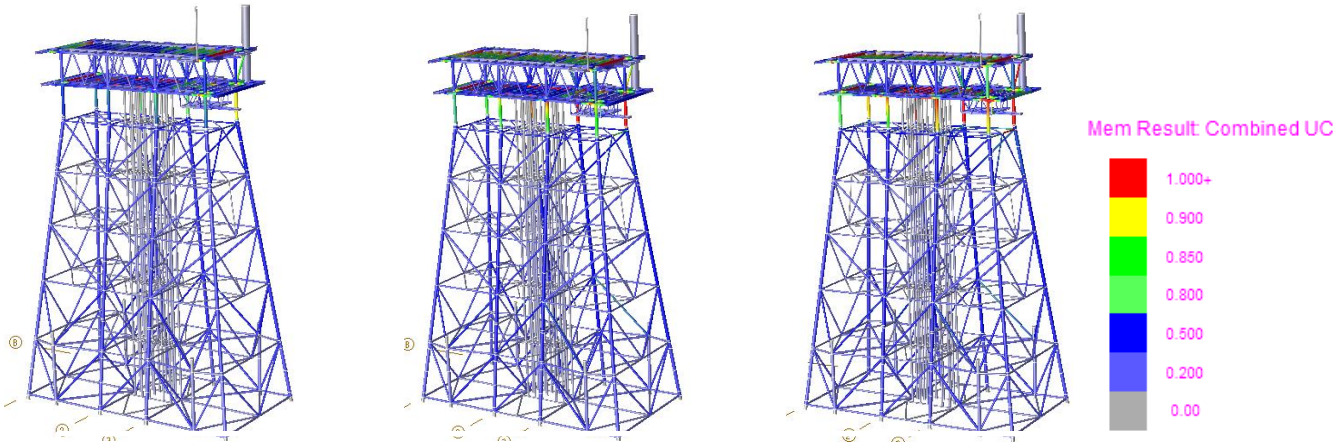
Figure (12). UC range of Members in first (1), second (2) and Third (3) Scenarios

Regarding the results of linear seismic analysis, the legs in the splash zone between the working point to the deck legs are in the critical range of unity check. UC of mentioned legs is decreased along the members from up to downward. Most of the braces are in the UC range between 0.1 and 0.3. Also, horizontal members with UC 0.1 to 0.5 are in acceptable condition. Implemented damages like; flooding the members and corrosion have no significant effect on UC. The UC ranges in the second scenario are similar to the first one. Increasing the topside weight in the second scenario has led to an actual stress increase in deck legs. However, these mentioned increased stresses did not affect on strength of bracing members.

The UC values are higher than the two previous cases in the third scenario. Also, the number of members has nonlinear behavior. Regarding the results of the third scenario, the initial design criteria and the assumed corrosion rate are conservative and the structure has less corrosion rate in its present condition. Also, considered damages in the initial design have never occurred for the platform until 2020. The nonlinearity of the braces in all three cases indicates their design criteria following a more robust force such as wave force. By controlling the members above the soil surface, it was determined that the most critical members under the earthquake force in all three cases are the jacket legs connected to the deck. There are 0, 5 and, 7 members with critical UC in the first, second and, the third scenarios, respectively.

Figure (12) illustrates the UC range of jacket members which are located above the seabed.

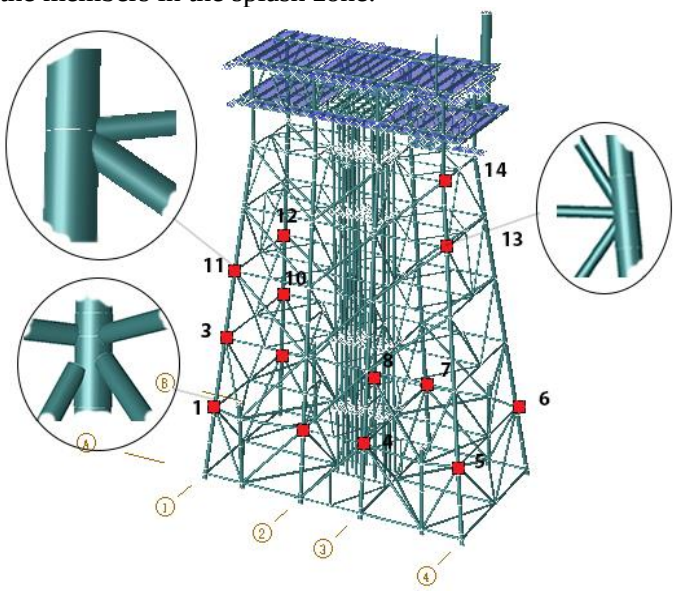
Figure (13). Jacket Critical joints

Tubular connection joints of the jacket have been checked as per API 22nd Edition criteria in both tensile and compression forces. The results show that most of the tubular joints are in an acceptable condition in all three scenarios. As illustrated in Figure (13), some of the joints located in the splash zone and other elevations with excessive corrosion rates are in critical condition and do not pass the API requirements.

As shown in Table (6), most of the overstressed joints are located at levels -37 meters and -52 meters with UC values greater than unity. However, these mentioned joints do not lead to non-linearization and collapse of the structure due to multiple load transfer paths and redundancy degree of structure. Regarding ELE analysis results, uniform corrosion has more effect on the joint strength of the corroded members than the strength of the exact members. The overall performance of the jacket structure, almost in all analyses, depends on the assumed corrosion rates for the members in the splash zone.

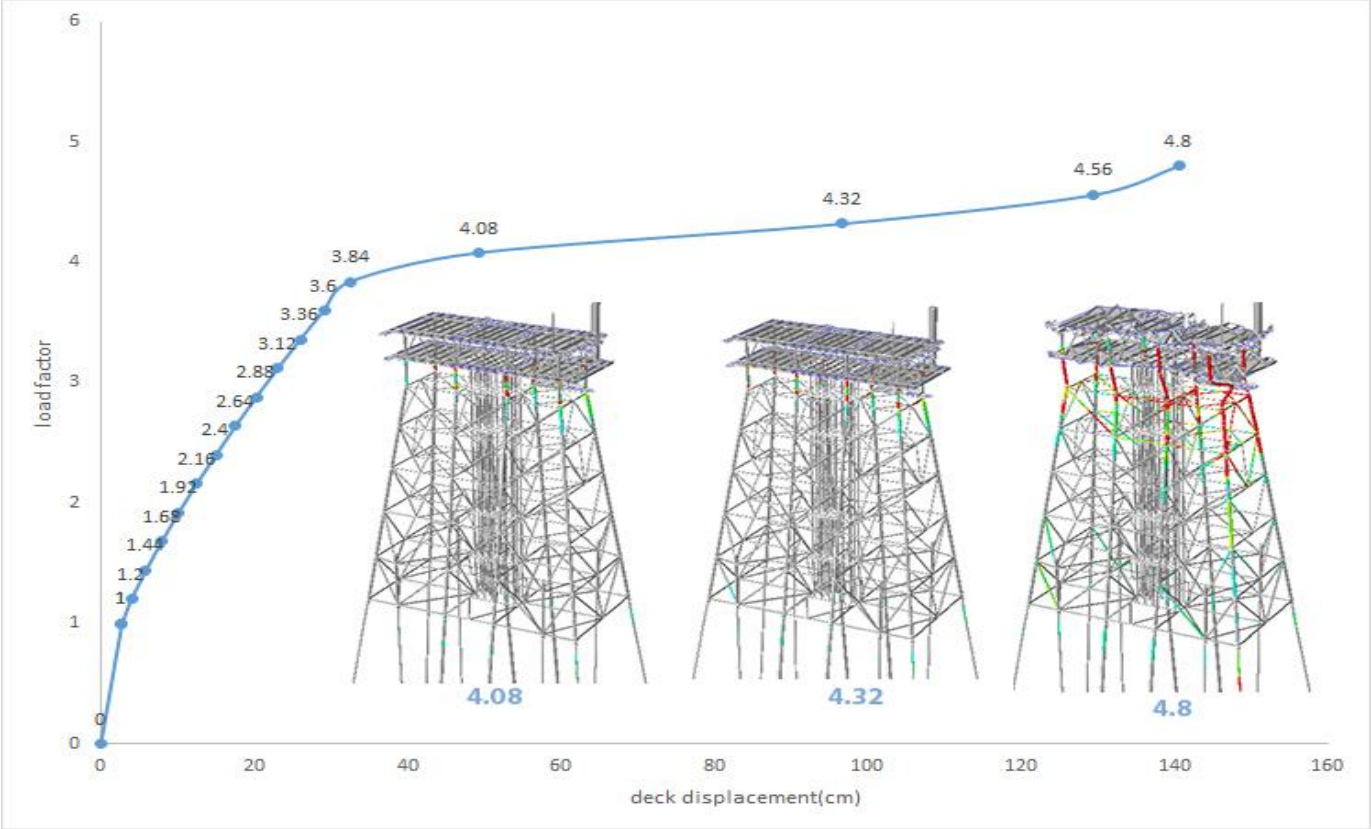
Figure 15. Capacity and Plasticization Rate of the Structure in the First Case

Regarding capacity diagram of the structure in the first scenario under abnormal level earthquake forces in direction No.1, Diagonal members are buckled and plastic hinges have occurred to develop in the deck legs. The first plasticization with a 16% rate occurred in the legs which connected to the deck at a load factor of 1.88. This mentioned plasticization has no significant effect on the behavior of the damaged structure.

While the loading process continues at a load factor of 2.84, the structure begins to yield and reduce stiffness. Plasticization of skirt piles and some horizontal members begin at the highest level of the jacket at a load factor of 3.08. Plasticization of the other horizontal members of the seadeck is stared at load factor 3.32. The first yield has occurred on the deck legs in the splash zone due to corrosion and lack of diagonal braces in this elevation. A plastic joint on the deck legs with in load factor of 3.56 has led to a change in the transmission of force from the legs to the horizontal members and VDM braces. Finally, 100% plasticization of deck legs and piles in the soil leads to the collapse of the structure at a load factor of 3.8. Figure (15) shows the displacement - load coefficient of the structure under gravity and lateral loads. The load factor from 0 to 1 is related to gravity loads. During the pushover analysis in the first scenario, no punching occurred in the piles and the soil has sufficient strength under the abnormal earthquakes up to a load factor of 3.8.

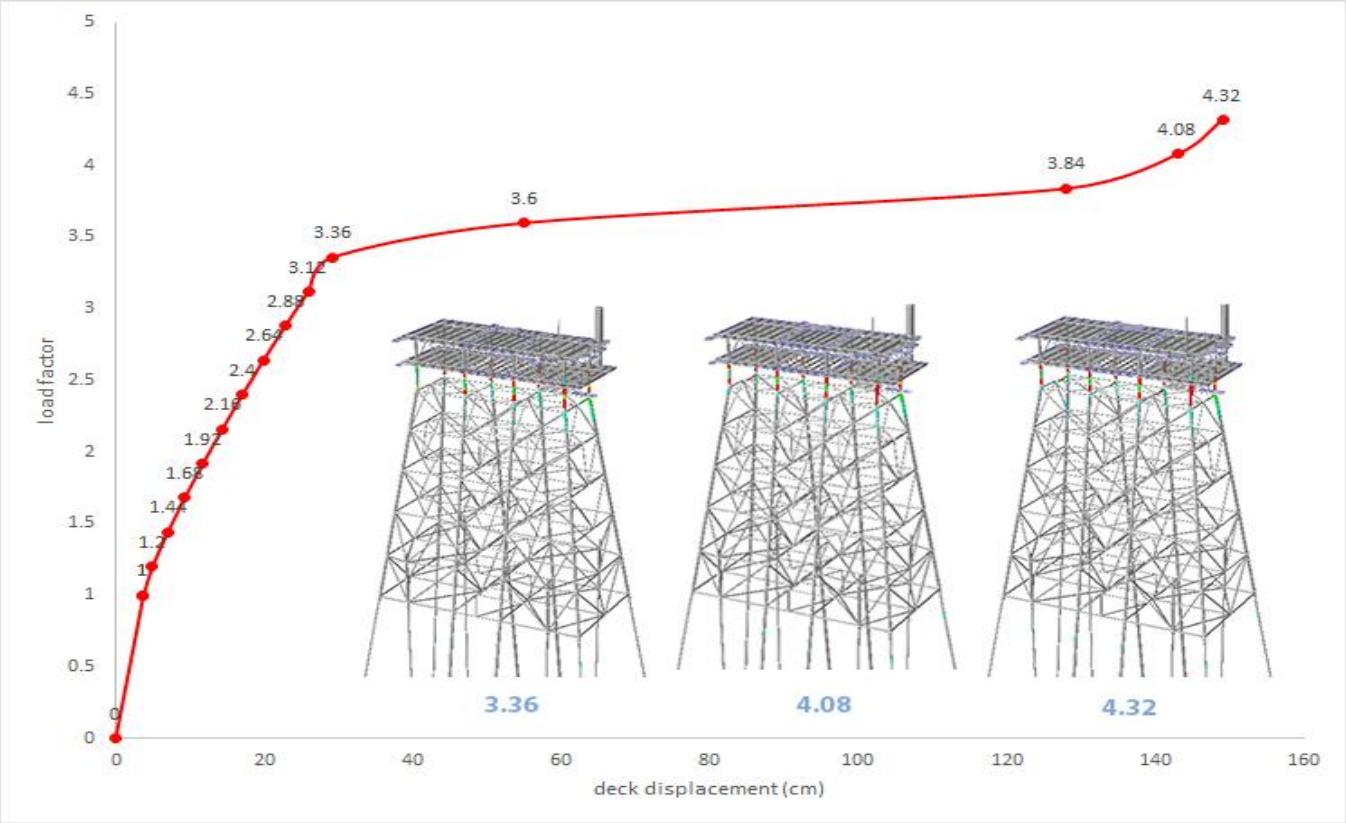
Figure 16. Capacity and Plasticization Rate of the Structure in the Second Case

The second scenario represents the actual condition of the structure. In the current scenario, due to the increase of the deck's weight, the members' plasticization occurred at a lower load factor with a higher percentage of yield. However, this increased weight has no significant effect on the fracture mechanism of the structure. The leg of the jacket and the diagonal braces have considerable roles against seismic load, respectively. No punching has occurred on the piles below the mudline. Also, plasticization of the piles has decreased along the piles from up to downward. The first yield has occurred in the deck leg, which is located below the crane. Although, plasticity is developed, platform failure is not happening and conforms to the ALE requirement. The structural leg elements are allowed to behave plastically developing the reserve strength of the cross-section, and making use of ductility and energy dissipation to resist ALE factors. Figure (16) illustrates the capacity diagram of the structure.

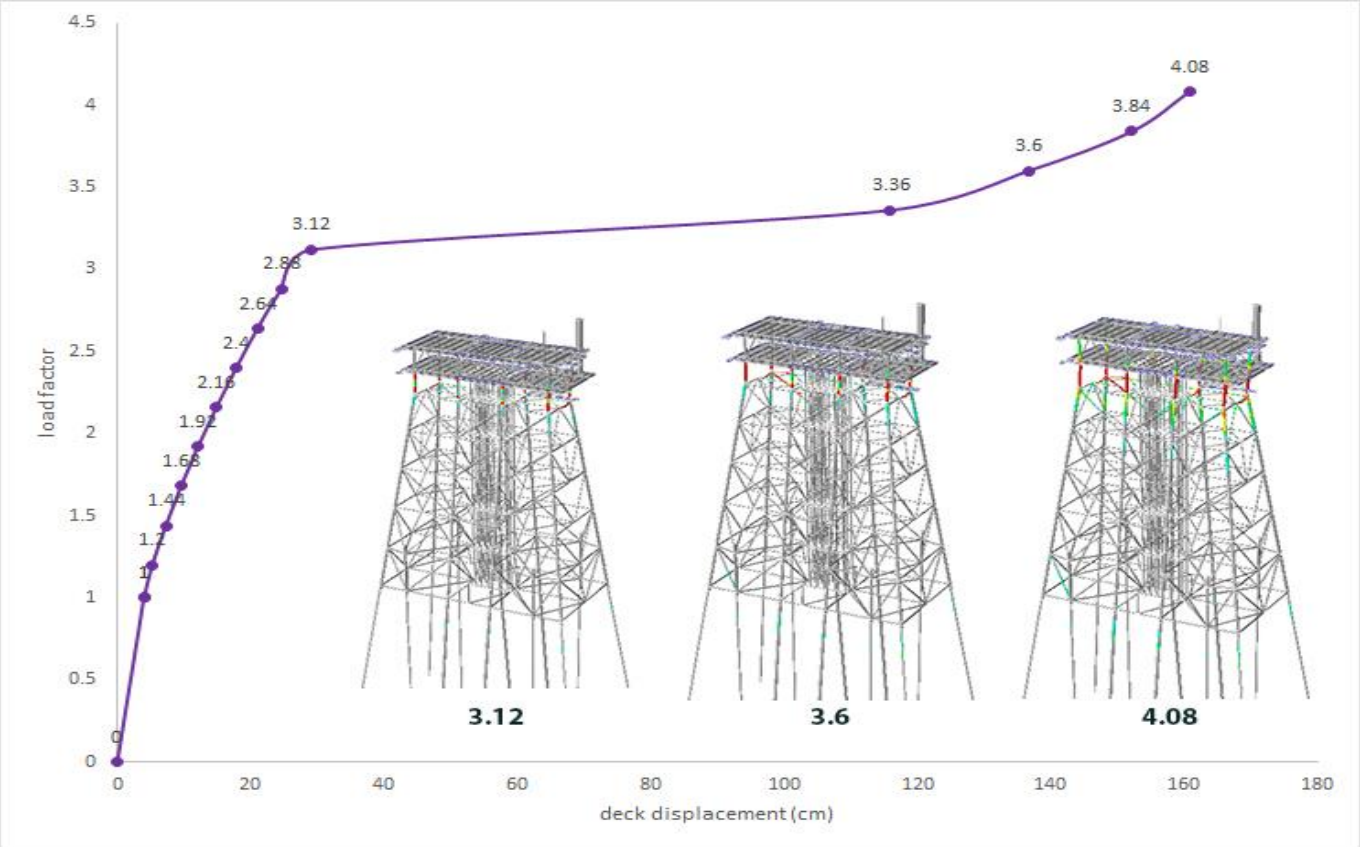
Figure 17. Capacity and Plasticization Rate of the Structure in the Third Case

The behavior of the structure in the third case is similar to the two other scenarios. However, the strict criteria and the considered damages in the initial design criteria of the structure have not happened properly. Although, damages in the initial design basis are more conservative than in other cases, and the actual condition of the platform and led to the collapse of the structure at a lower load factor than the other two cases. The 8% difference in the Strength ratio between the second and third scenarios indicates the effect of damages like corrosion on the RSR of the structure. The bending has occurred on the deck legs below the heavy crane. Also, diagonal braces which are located near the crane are near to buckle. The result of the global inelastic seismic analysis of the structure indicates that the structure has suffered damages consisting of the buckling of some diagonal braces in the splash zone and the yielding of deck legs during the abnormal earthquake. So, the platform has a minimum RSR of 3.32 under a 1,000-year return period earthquake event. It is concluded that despite the poor performance and condition of some members and joints, especially in the splash zone and deck legs, the platform can fulfill API for the structural assessment against seismic loads.
