Evaluation of Seismic Behavior of Damaged Offshore Jacket Platform under the Environmental Conditions

Amirreza Zafarjoo¹, Rouhollah Amirabadi^{2*}

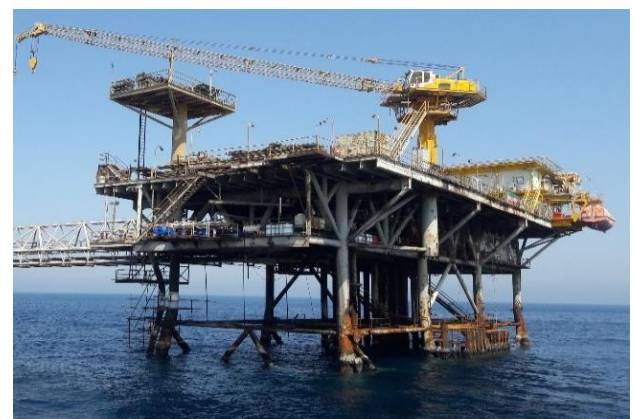
The presented structure is an 8-leg drilling platform with four skirt piles with L₁ exposure categories in the Persian Gulf. The mentioned platform was built in 1960 and has suffered from several damages during Iran/Iraq war. Subsea Jacket structural inspection was carried out in 2001 and 2013. Also, the topside weight was reduced to 2000 tons by removing the drilling rig in 2013 as an SMR operation method. Figure 1 illustrates a general view of the drilling platform.

Figure 1. General View of the Drilling Platform

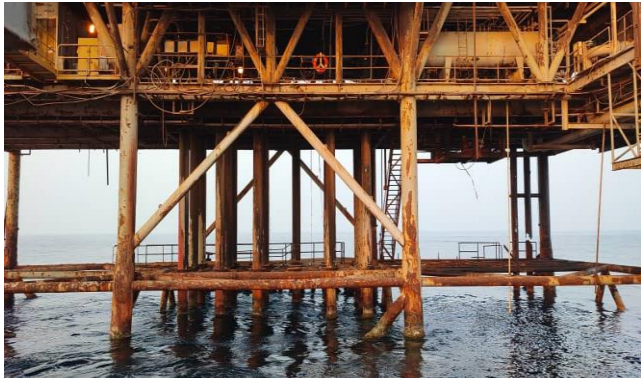
Regarding actual subsea inspection reports, several structural members are suffering from excessive corrosion, flooding, marine growth effects, and anode wastage. No fractures or dents were observed in the members and welds [17]. Figure 2 shows the general condition of the jacket members in the splash zone.

Figure 2. General Condition of Members in Splash zone

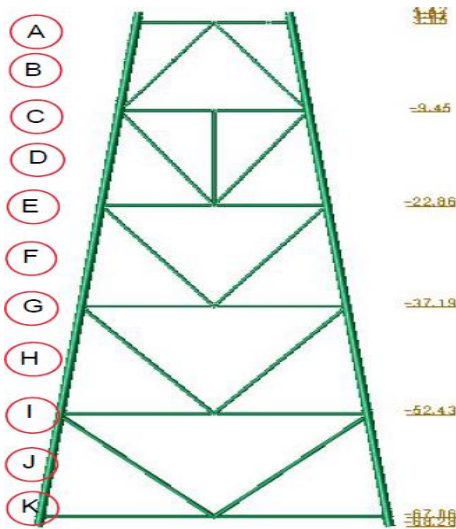
Table 1, Table 2, and Table 3 illustrate structure design specifications, marine growth inspection reports and member corrosion rates based on subsea inspection, respectively. To easier reporting, each elevation of the jacket has been named separately, as shown in Figure 3.

Figure 3. Tag Name of the Each Elevation on DP [17]

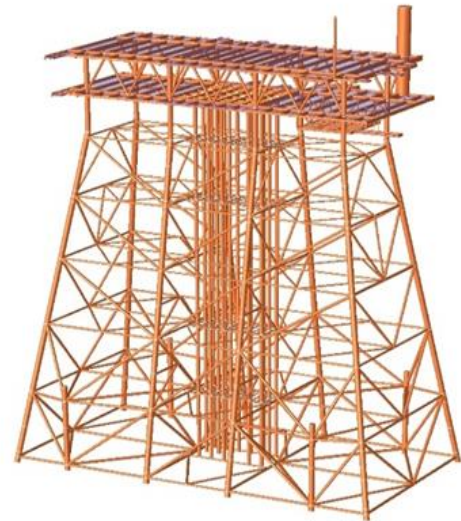
A series of analyses have been performed with the aforementioned above procedure for all directions to achieve critical RSR of the structure. Figure 4 and Figure 5 illustrate topside and jacket modeling in SACS software, respectively. It is noted that, as per API2EQ 2014, No other environmental load is assumed to act concurrently with the seismic loads.

Figure 5. Jacket Modeling in SACS Software

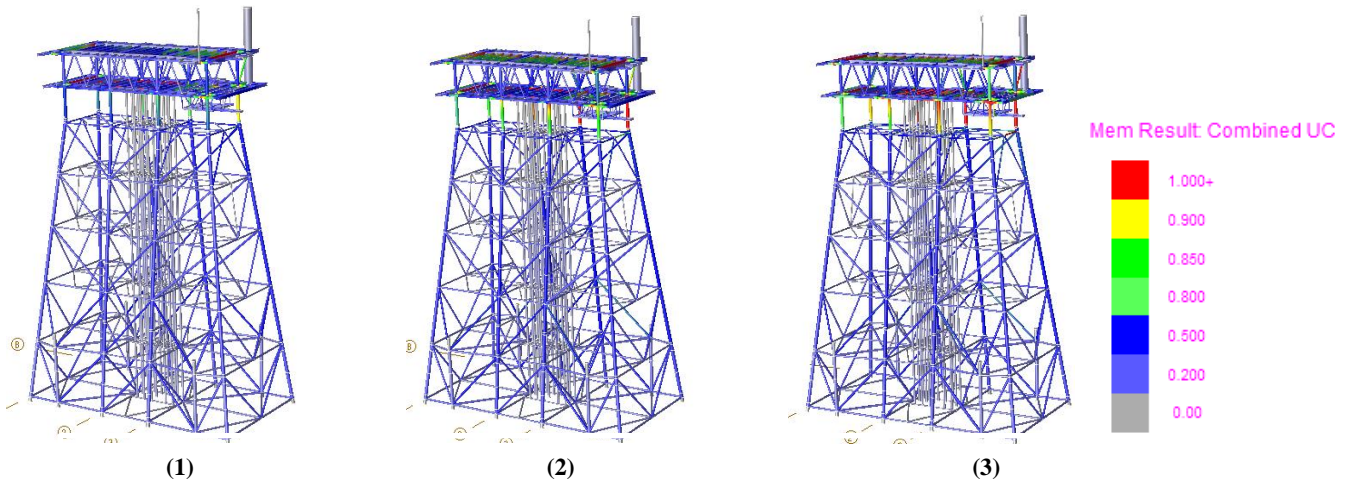
Figure (12) illustrates the UC range of jacket members which are located above the seabed.

Figure (12). UC range of Members in first (1), second (2) and Third (3) Scenarios

nonlinear behavior. Regarding the results of the third scenario, the initial design criteria and the assumed corrosion rate are conservative and the structure has less corrosion rate in its present condition. Also, considered damages in the initial design have never occurred for the platform until 2020. The nonlinearity of the braces in all three cases indicates their design criteria following a more robust force such as wave force. By controlling the members above the soil surface, it was determined that the most critical members under the earthquake force in all three cases are the jacket legs connected to the deck. There are 0, 5 and, 7 members with critical UC in the first, second and, the third scenarios, respectively.

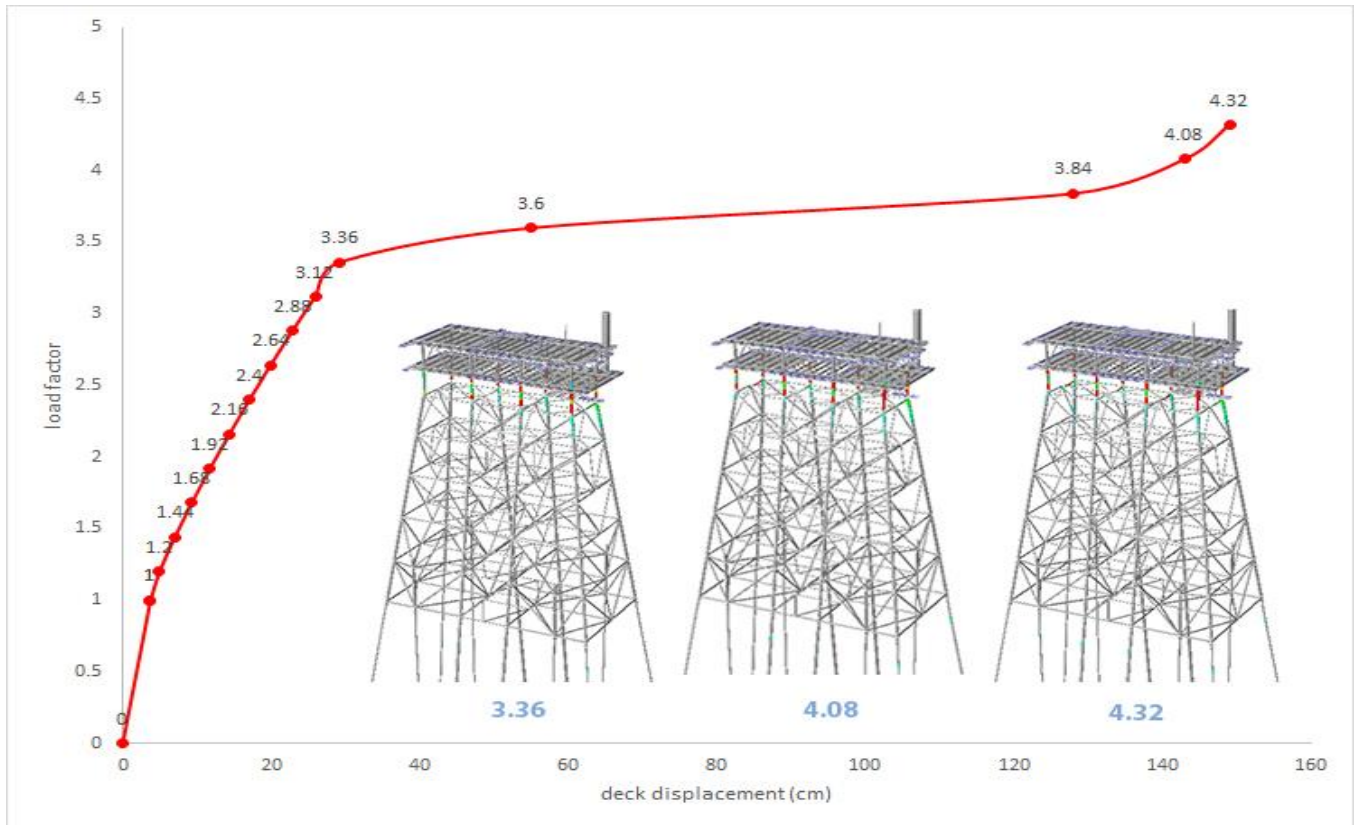
The second scenario represents the actual condition of the structure. In the current scenario, due to the increase of the deck's weight, the members' plasticization occurred at a lower load factor with a higher percentage of yield. However, this increased weight has no significant effect on the fracture mechanism of the structure. The leg of the jacket and the diagonal braces have considerable roles against seismic load, respectively. No punching has occurred on the piles below the mudline. Also, plasticization of the piles has

decreased along the piles from up to downward. The first yield has occurred in the deck leg, which is located below the crane. Although, plasticity is developed, platform failure is not happening and conforms to the ALE requirement. The structural leg elements are allowed to behave plastically developing the reserve strength of the cross-section, and making use of ductility and energy dissipation to resist ALE factors. Figure (16) illustrates the capacity diagram of the structure.

Figure 16. Capacity and Plasticization Rate of the Structure in the Second Case
