Evaluation of Seismic Behavior of Damaged Offshore Jacket Platform under the Environmental Conditions

2. Platform Descriptions

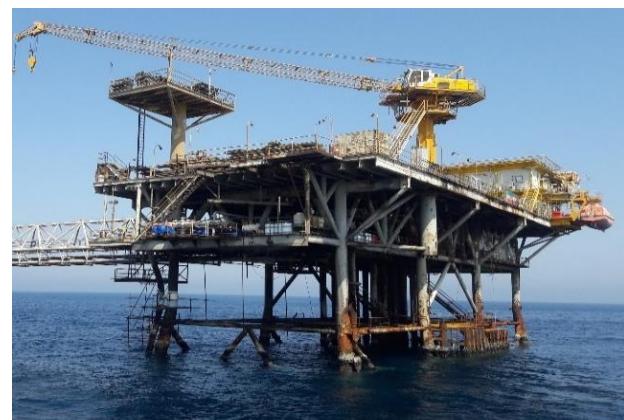
Figure 1. General View of the Drilling Platform

The presented structure is an 8-leg drilling platform with four skirt piles with L_1 exposure categories in the Persian Gulf. The mentioned platform was built in 1960 and has suffered from several damages during Iran/Iraq war. Subsea Jacket structural inspection was carried out in 2001 and 2013. Also, the topside weight was reduced to 2000 tons by removing the drilling rig in 2013 as an SMR operation method. Figure 1 illustrates a general view of the drilling platform.

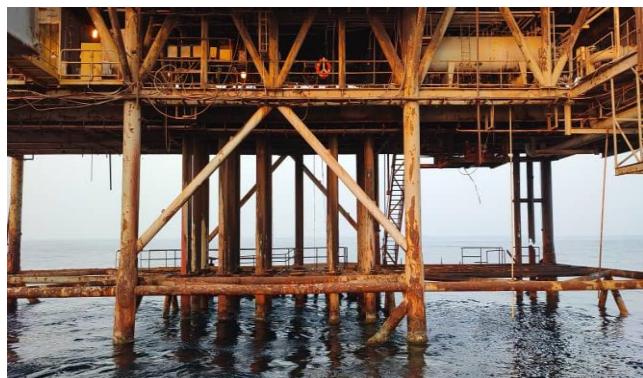
Figure 2. General Condition of Members in Splash zone

Regarding actual subsea inspection reports, several structural members are suffering from excessive corrosion, flooding, marine growth effects, and anode wastage. No fractures or dents were observed in the members and welds [17]. Figure 2 shows the general condition of the jacket members in the splash zone.

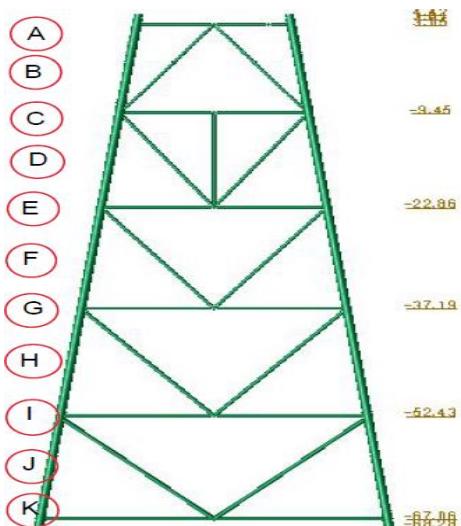
Figure 3. Tag Name of the Each Elevation on DP [17]

Table 1, Table 2, and Table 3 illustrate structure design specifications, marine growth inspection reports and member corrosion rates based on subsea inspection, respectively. To easier reporting, each elevation of the jacket has been named separately, as shown in Figure 3.

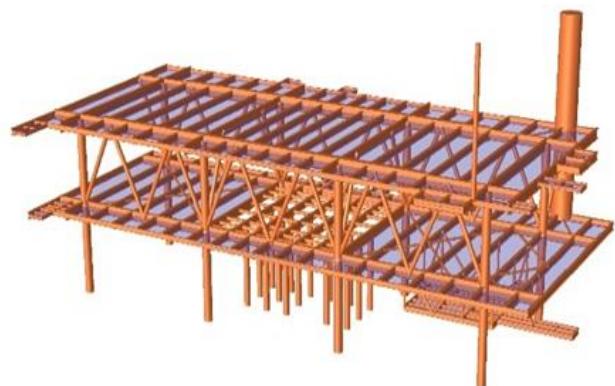
Figure 4. Topside Modeling in SACS Software

A series of analyses have been performed with the aforementioned above procedure for all directions to achieve critical RSR of the structure. Figure 4 and Figure 5 illustrate topside and jacket modeling in SACS software, respectively. It is noted that, as per API2EQ 2014, No other environmental load is assumed to act concurrently with the seismic loads.

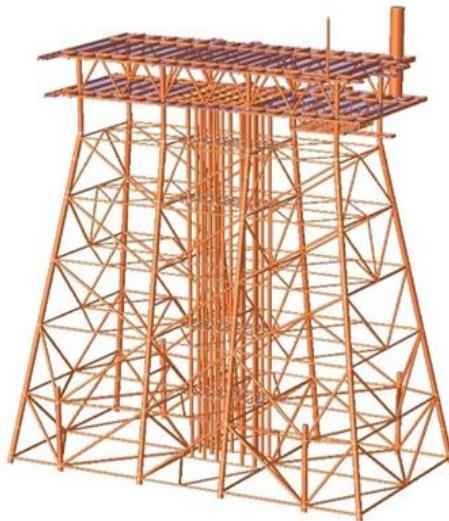
Figure 5. Jacket Modeling in SACS Software

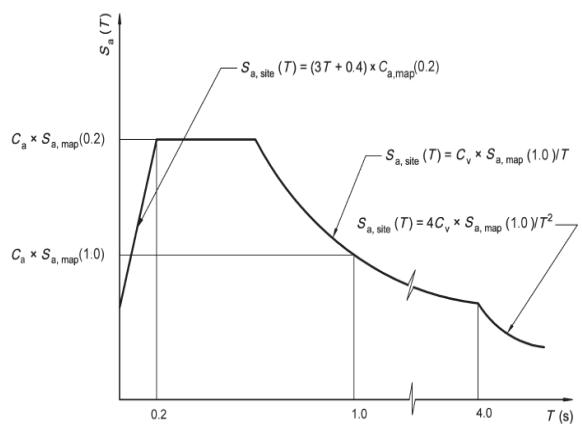
Figure 6. Earthquake Spectrum of API2014 Code [2]

To determine the magnitude of the earthquake spectrum at the two levels of ALE and ELE, the design spectrum of API-RP2EQ-2014 with a 5% damping ratio is calculated according to Figure 6 and, Eq. 1, 2 and, 3 [2].

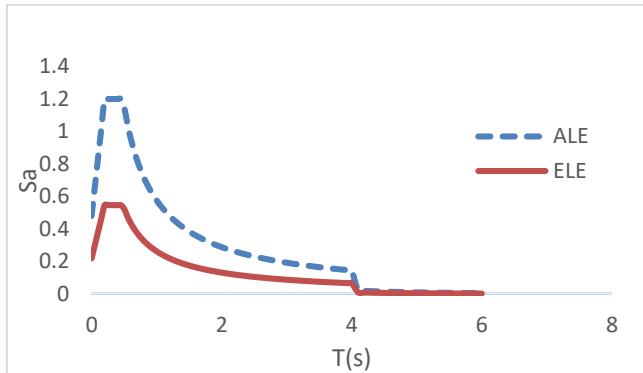
Figure 7. ALE and ELE Level Design Spectrum

Following the actual geotechnical survey reports, the site soil class is categorized in level E and the C_a and, C_v coefficients are equal to 1 and 1.8, respectively [19]. The calculated spectra for two earthquake levels are presented in Figure 7:

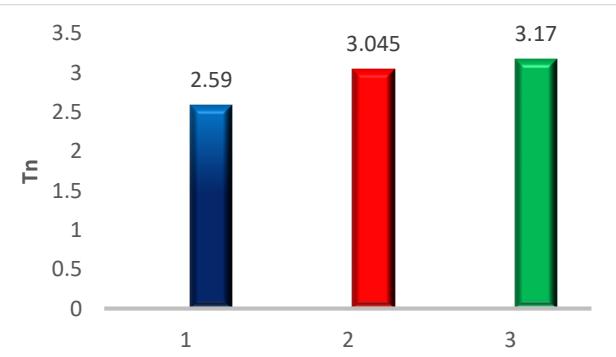
Figure 8. Comparison Diagram of the Natural Period of the Structure in all Three Scenarios

A total of 50 modes were extracted to obtain a cumulative mass participation factor of more than 90% in all directions. As shown in Figure (8), damages and defects have no significant effect on the natural period of the structure. Although, load reduction of the structure by 16% make decrease the natural period by 0.5 seconds. According to Figure (9), the natural periods of the structure are identical in all three cases from the fourth mode onwards. The vibrational modes of the structure are similar in all three modes and have not been affected by weight loss and damage. Figure (10) illustrates the first three modes of the platform in all three scenarios.

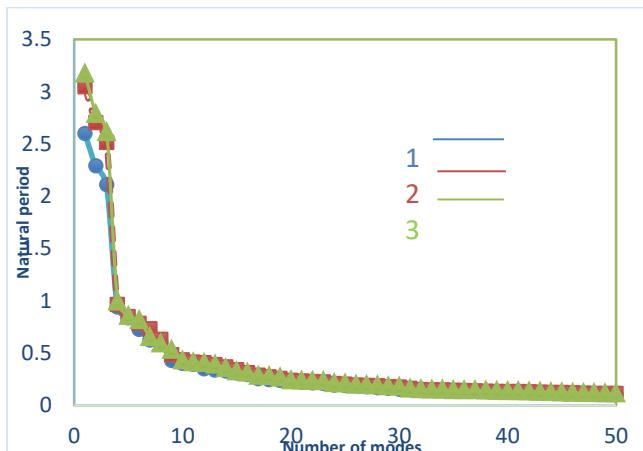
Figure 9. Comparison of Natural Period of Structure in all Three Scenarios

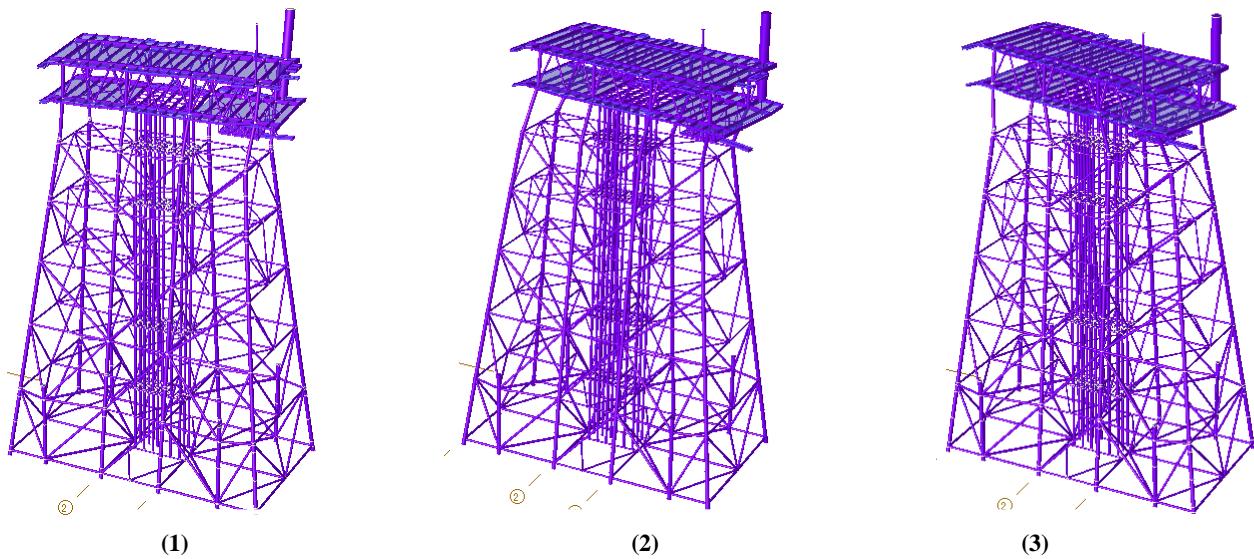
Figure 10. First Three Modes of the Structure in Three Scenarios

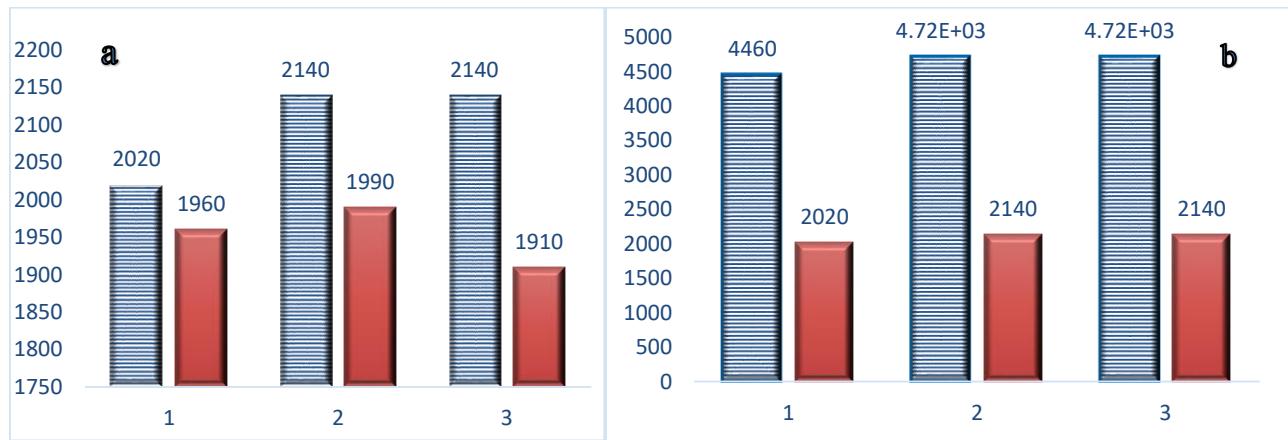
Figure 11. Base Shear Results in Extreme (a) and Abnormal (b) Levels for All Three Scenarios

The result of base shear checks along two directions in all three scenarios has shown in Figure (11). Increasing Weight due to flooding of some members has no significant effect on the structure's weight. However, weight reduction of the topside by 16% decreases the base shear by 5%.

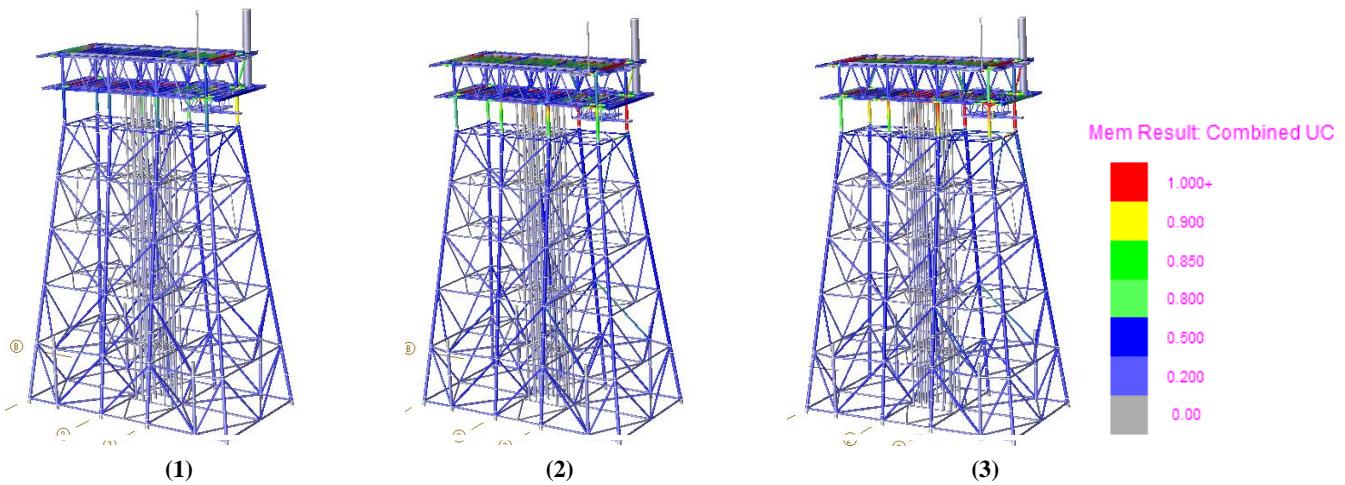
Figure (12). UC range of Members in first (1), second (2) and Third (3) Scenarios

Figure (12) illustrates the UC range of jacket members which are located above the seabed.

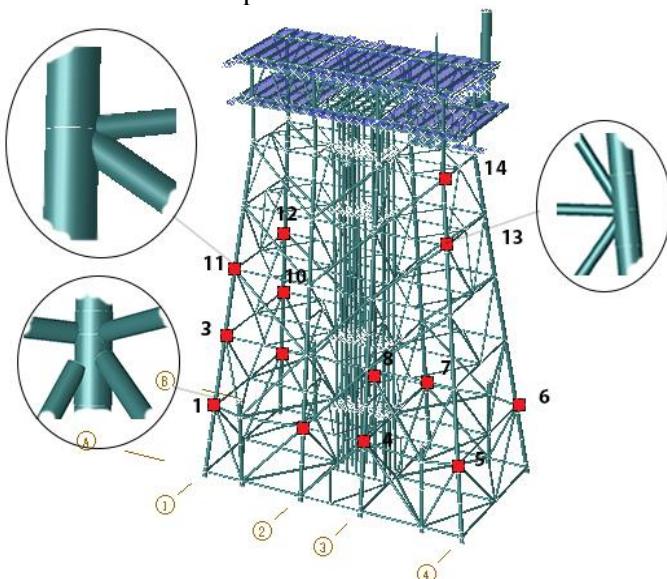
Figure (13). Jacket Critical joints

Tubular connection joints of the jacket have been checked as per API 22nd Edition criteria in both tensile and compression forces. The results show that most of the tubular joints are in an acceptable condition in all three scenarios. As illustrated in Figure (13), some of the joints located in the splash zone and other elevations with excessive corrosion rates are in critical condition and do not pass the API requirements.

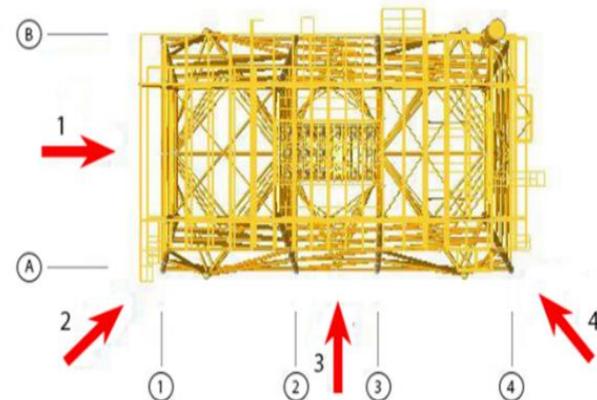
Figure 14: Directions of Implemented Forces in Pushover Analysis

The base shear in the first direction is higher than in other directions. The structural collapse of the jacket in the diagonal direction can be due to the behavior of the foundation. However, in this structure, the presence of

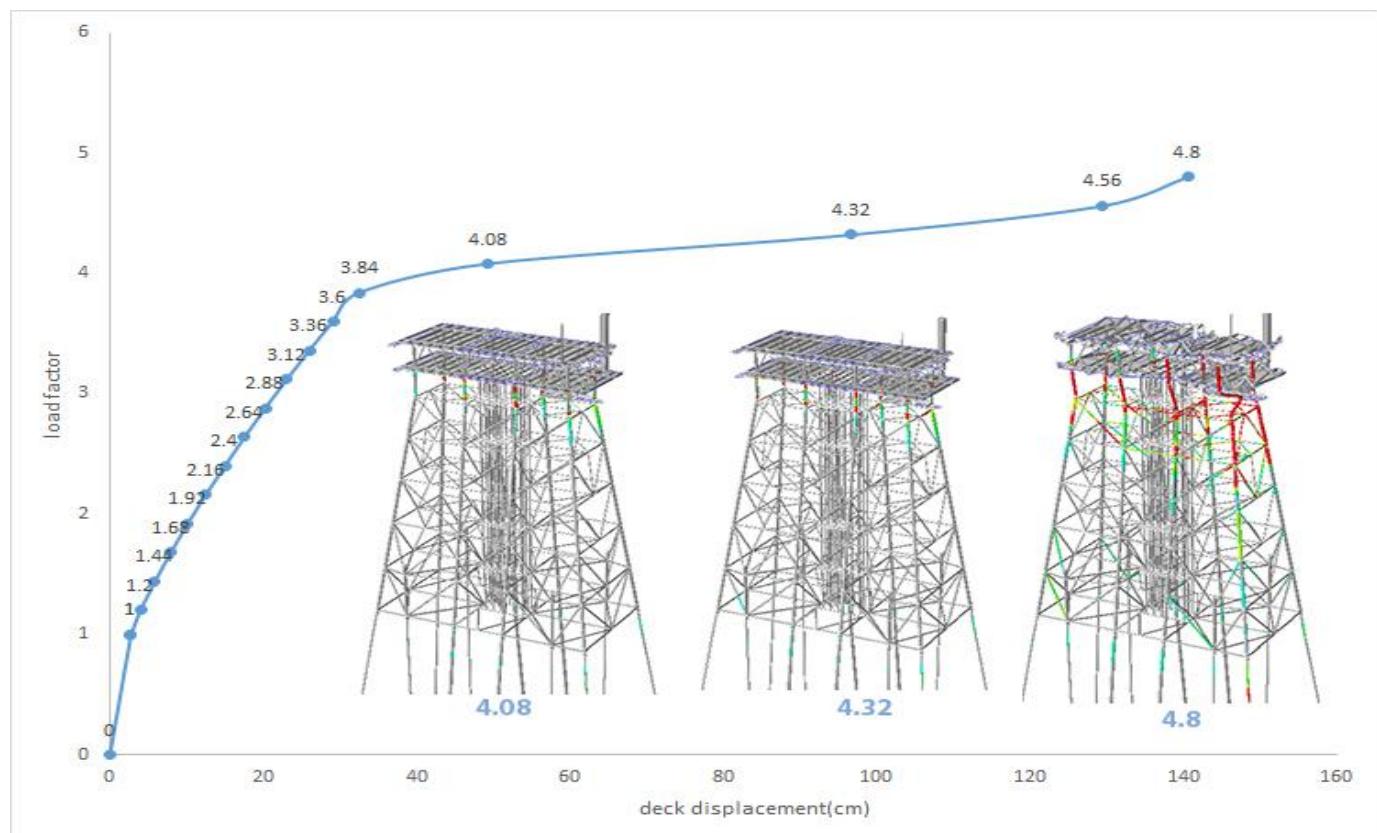
Figure 15. Capacity and Plasticization Rate of the Structure in the First Case

Regarding capacity diagram of the structure in the first scenario under abnormal level earthquake forces in direction No.1, Diagonal members are buckled and plastic hinges have occurred to develop in the deck legs. The first plasticization with a 16% rate occurred in the legs which connected to the deck at a load factor of 1.88. This mentioned plasticization has no significant effect on the behavior of the damaged structure.

While the loading process continues at a load factor of 2.84, the structure begins to yield and reduce stiffness.

Plasticization of skirt piles and some horizontal members begin at the highest level of the jacket at a load factor of 3.08. Plasticization of the other horizontal members of the seadeck is started at load factor 3.32. The first yield has occurred on the deck legs in the splash zone due to corrosion and lack of diagonal braces in this elevation. A plastic joint on the deck legs with in load factor of 3.56 has led to a change in the transmission of force from the legs to the horizontal members and VDM braces. Finally, 100% plasticization of deck legs and piles in the soil leads to the collapse of the structure at a load factor of 3.8. Figure (15) shows the displacement - load coefficient of the structure under gravity and lateral loads. The load factor from 0 to 1 is related to gravity loads. During the pushover analysis in the first scenario, no punching occurred in the piles and the soil has sufficient strength under the abnormal earthquakes up to a load factor of 3.8.

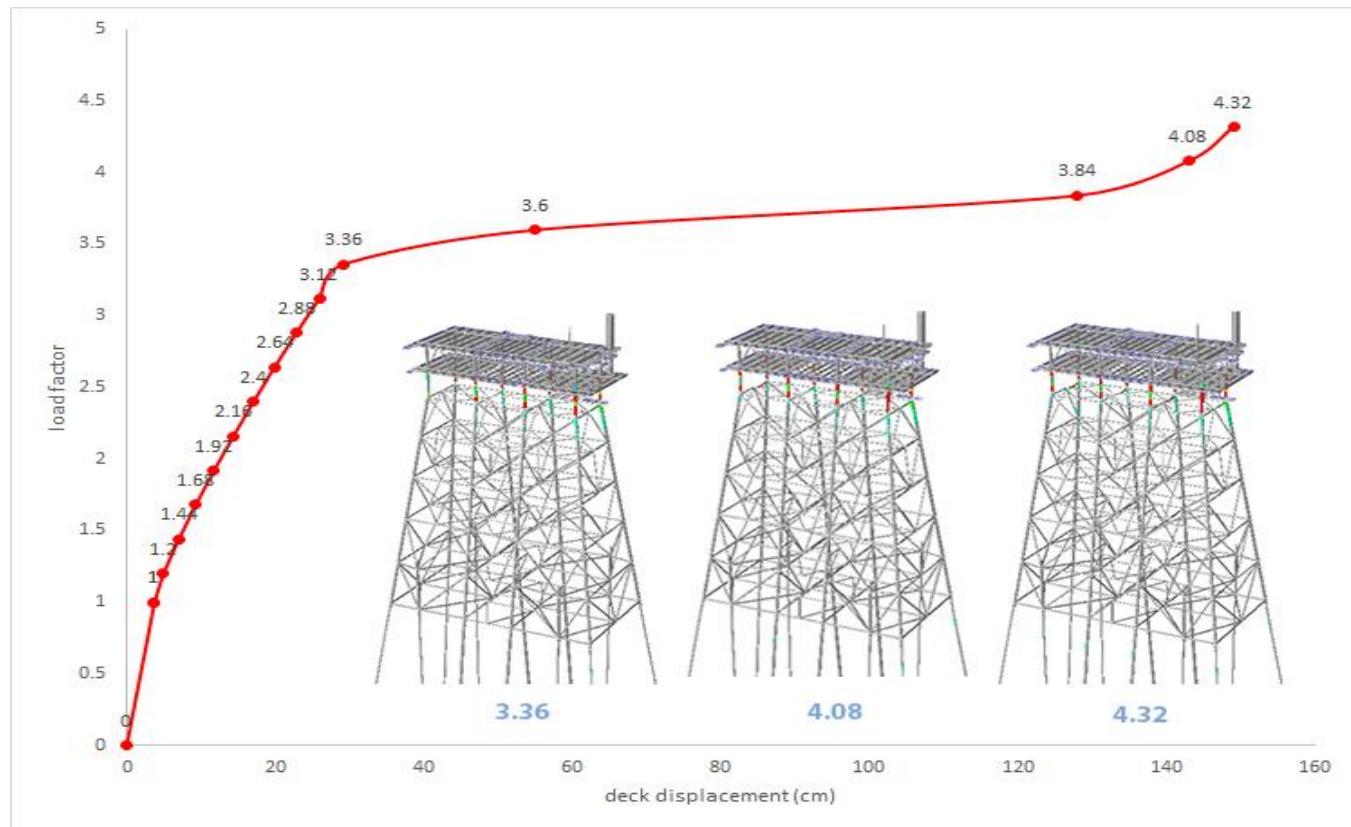
Figure 16. Capacity and Plasticization Rate of the Structure in the Second Case

The second scenario represents the actual condition of the structure. In the current scenario, due to the increase of the deck's weight, the members' plasticization occurred at a lower load factor with a higher percentage of yield. However, this increased weight has no significant effect on the fracture mechanism of the structure. The leg of the jacket and the diagonal braces have considerable roles against seismic load, respectively. No punching has occurred on the piles below the mudline. Also, plasticization of the piles has

decreased along the piles from up to downward. The first yield has occurred in the deck leg, which is located below the crane. Although, plasticity is developed, platform failure is not happening and conforms to the ALE requirement. The structural leg elements are allowed to behave plastically developing the reserve strength of the cross-section, and making use of ductility and energy dissipation to resist ALE factors. Figure (16) illustrates the capacity diagram of the structure.

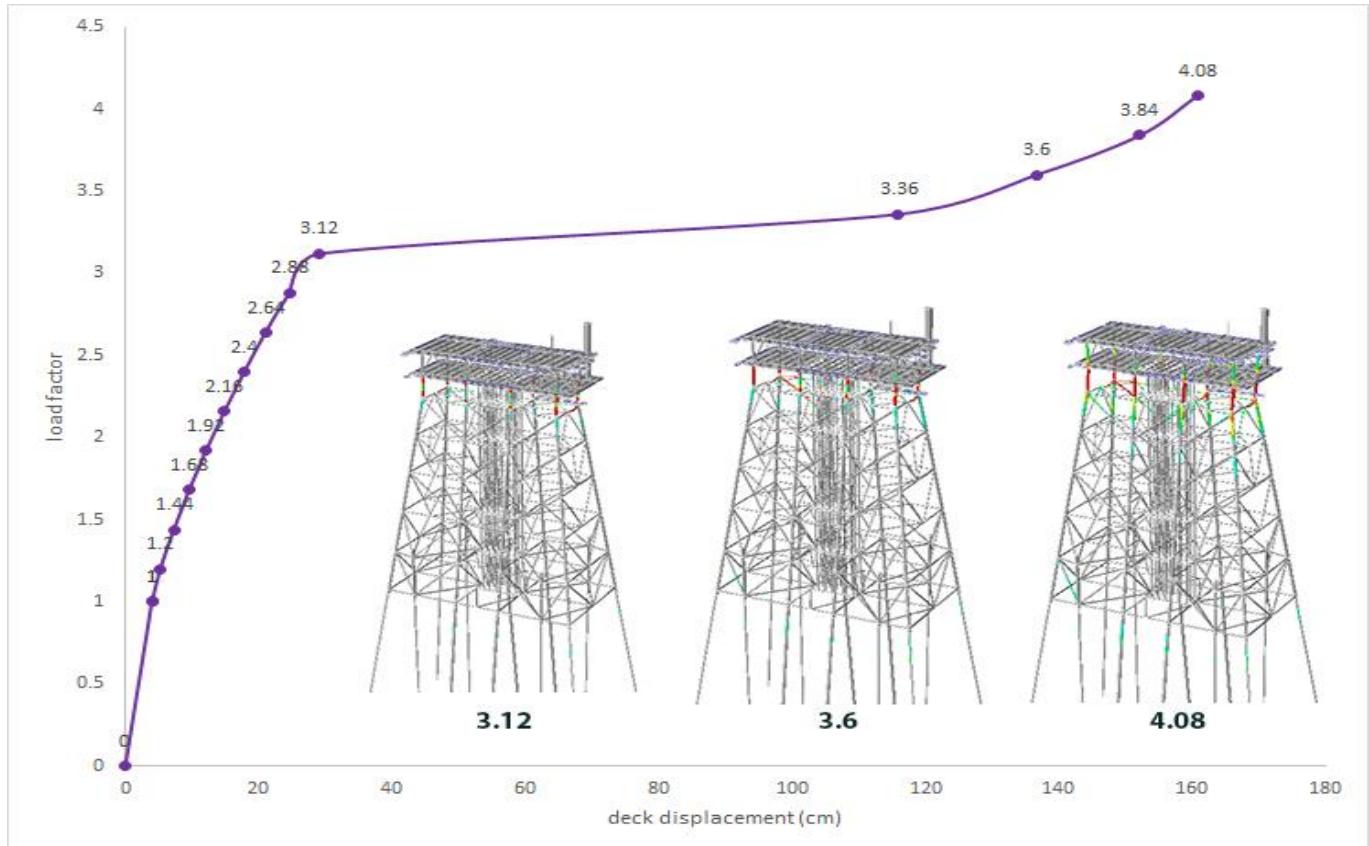
Figure 17. Capacity and Plasticization Rate of the Structure in the Third Case

The behavior of the structure in the third case is similar to the two other scenarios. However, the strict criteria and the considered damages in the initial design criteria of the structure have not happened properly. Although, damages in the initial design basis are more conservative than in other cases, and the actual condition of the platform and led to the collapse of the structure at a lower load factor than the other two cases. The 8% difference in the Strength ratio between the second and third scenarios indicates the effect of damages like corrosion on the RSR of the structure. The bending has occurred on the deck legs below the

heavy crane. Also, diagonal braces which are located near the crane are near to buckle. The result of the global inelastic seismic analysis of the structure indicates that the structure has suffered damages consisting of the buckling of some diagonal braces in the splash zone and the yielding of deck legs during the abnormal earthquake. So, the platform has a minimum RSR of 3.32 under a 1,000-year return period earthquake event. It is concluded that despite the poor performance and condition of some members and joints, especially in the splash zone and deck legs, the platform can fulfill API for the structural assessment against seismic loads.

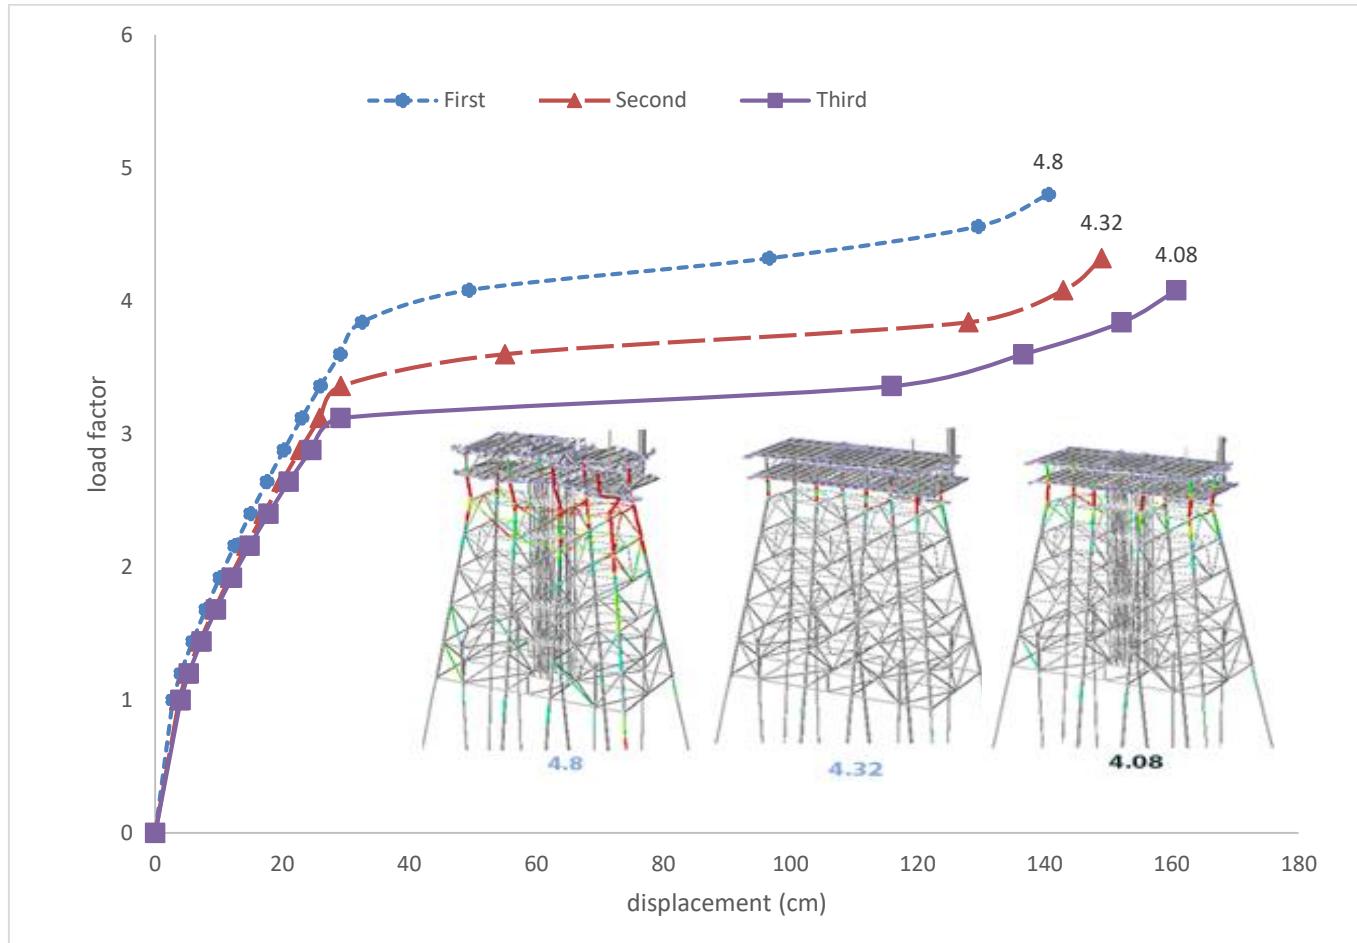
Figure 18. Comparison of Capacity Diagrams in Three Scenarios
