Evaluation of Seismic Behavior of Damaged Offshore Jacket Platform under the Environmental Conditions

ABSTRACT

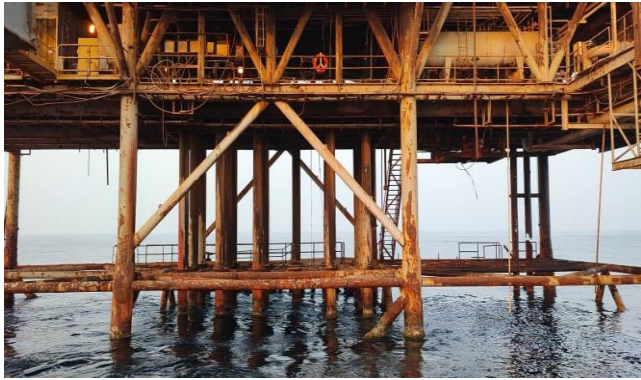
Figure 2. General Condition of Members in Splash zone

Regarding actual subsea inspection reports, several structural members are suffering from excessive corrosion, flooding, marine growth effects, and anode wastage. No fractures or dents were observed in the members and welds [17]. Figure 2 shows the general condition of the jacket members in the splash zone.
