Evaluation of Seismic Behavior of Damaged Offshore Jacket Platform under the Environmental Conditions

Amirreza Zafarjoo¹, Rouhollah Amirabadi^{2*}

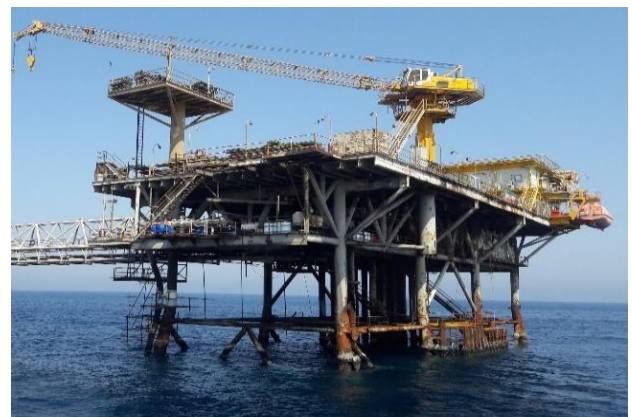
Figure 1. General View of the Drilling Platform

The presented structure is an 8-leg drilling platform with four skirt piles with L₁ exposure categories in the Persian Gulf. The mentioned platform was built in 1960 and has suffered from several damages during Iran/Iraq war. Subsea Jacket structural inspection was carried out in 2001 and 2013. Also, the topside weight was reduced to 2000 tons by removing the drilling rig in 2013 as an SMR operation method. Figure 1 illustrates a general view of the drilling platform.

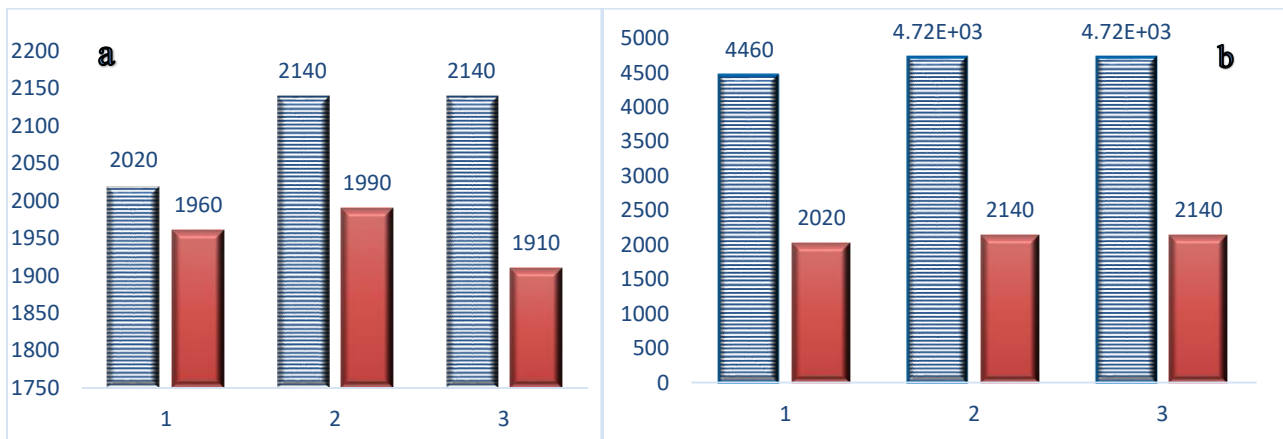
Figure 11. Base Shear Results in Extreme (a) and Abnormal (b) Levels for All Three Scenarios

The result of base shear checks along two directions in all three scenarios has shown in Figure (11). Increasing Weight due to flooding of some members has no significant effect on the structure's weight. However, weight reduction of the topside by 16% decreases the base shear by 5%.

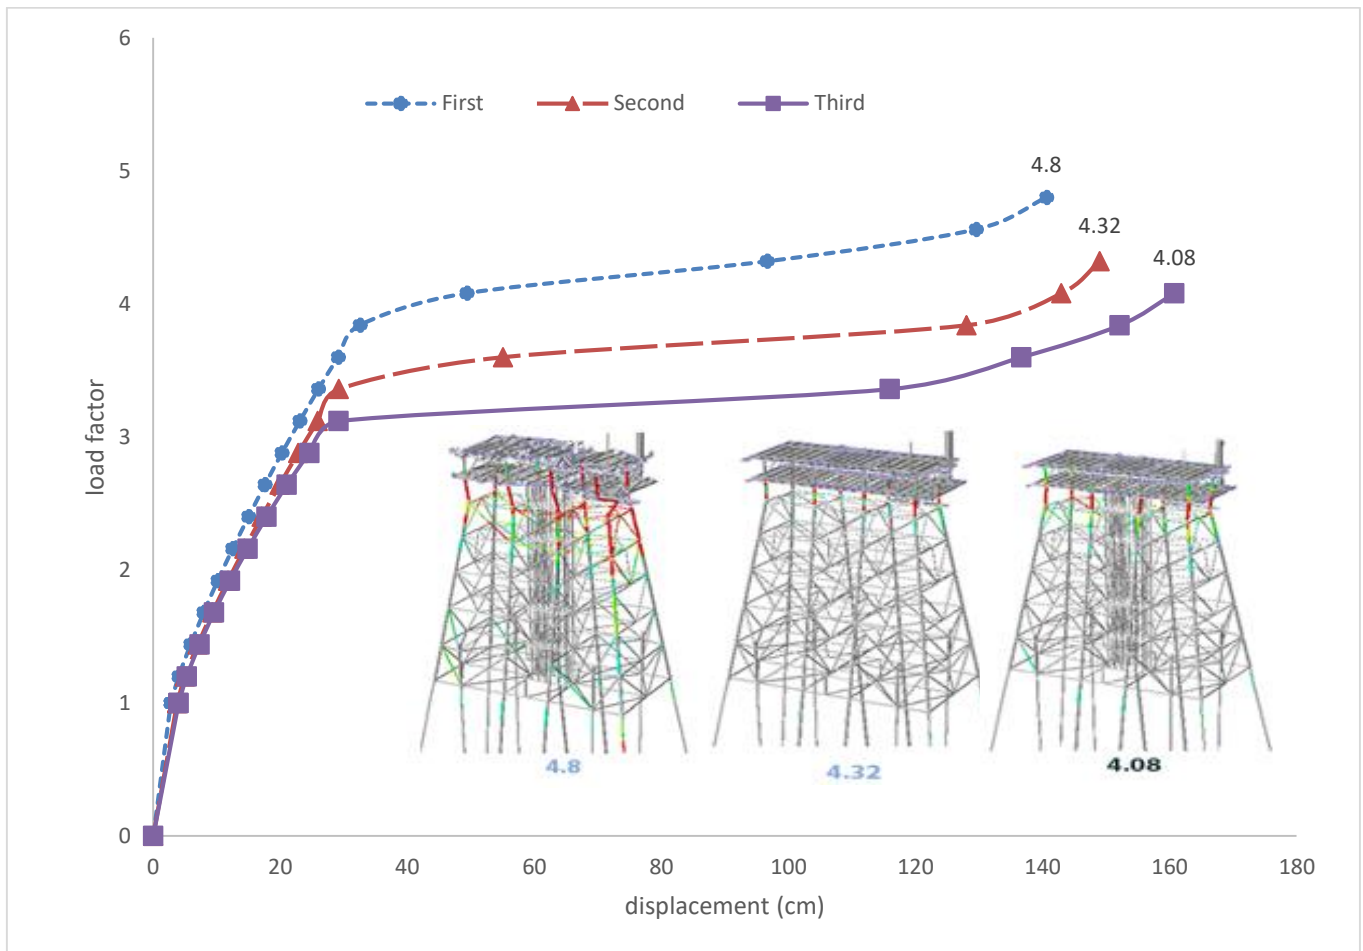
Figure 18. Comparison of Capacity Diagrams in Three Scenarios

6. According to Figure 18, the implemented damages have no considerable effect on the structure's integrity. Also, reducing or increasing the weight of the topside has led to changes in the RSR and the percentage of plasticization of critical members.
